# Exhibit 4

Issue Number:	<b>N172404</b>	PDF Date Submitted	01/07/2005

<input checked="" type="checkbox"/> Part - Location:	<b>Ignition Key Cylinder Assembly -Column - Steering</b>				
<input checked="" type="checkbox"/> Complaint:	<b>vehicle can be keyed off with knee while driving</b>				
Issue Type:	<b>Current Prod</b>	Vehicle/Product Line:	<b>3Acar</b>		Region:
<input checked="" type="checkbox"/> Severity:	<b>3</b>	Primary Metric/Score:	<b>LaunchX / 0.025</b>

Primary Project No:	Cobalt	Model Year:	2005
Other Project No(s):	05X001	Model Year Qtr:	
Vehicle/Prop. #:		Model Code:	
Marketing Division:	Chevrolet, Pontiac	Hardware Stage:	
Marketing Region(s):		(VIN) Vehicle ID #:	
Engine(s):		Transmission(s):	
Engine Serial #:		Transmission Serial #:	
Drive Type(s):		Option(s):	
Steering:		PIMREP No:

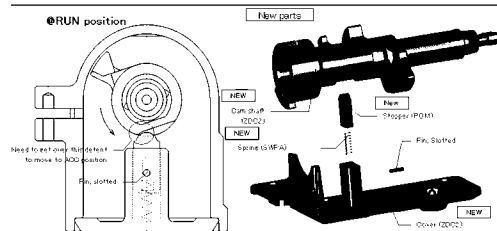
➤ Detent between lock cover and cam shaft:

- ✓ Partial solution based on engineering judgment. No experimental verification that detent is sufficient.
- ✓ If chosen, will drive changes and tuning efforts in ignition switch in order to avoid double detent feel.
- ✓ Design has to become common between Delta, Theta and Kappa
- ✓ Can be combined with the new ignition switch presently sourced for GMT191/2/3 for better detent
